SECTION 08550 - EXISTING WOOD WINDOW RESTORATION

The Repair of Historic Wooden Windows

John H. Myers

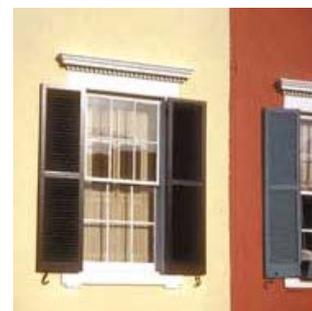
Historic six-over-six windows--preserved. Photo: NPS files.

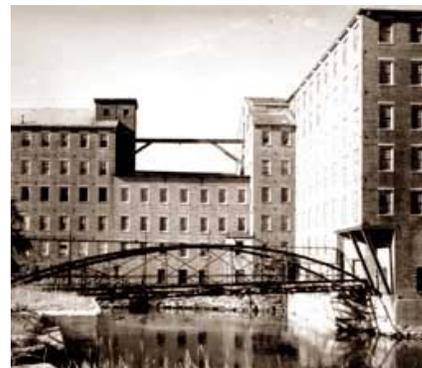
Windows are frequently important visual focal points, especially on simple facades such as this mill building. Replacement of the multi-pane windows with larger panes could dramatically alter the appearance of the building. Photo: NPS files.

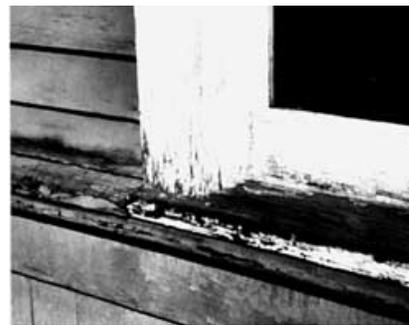
Deterioration of poorly maintained windows usually begins on horizontal surfaces and at joints, where water can collect and saturate the wood. Photo: NPS files.

Many factors such as poor design, moisture, vandalism, insect attack, and lack of maintenance can contribute to window deterioration, but moisture is the primary contributing factor in wooden window decay. All window units should be inspected to see if water is entering around the edges of the frame and, if so, the joints or seams should be caulked to eliminate this danger. The glazing putty should be checked for cracked, loose, or missing sections which allow water to saturate the wood, especially at the joints. The back putty on the interior side of the pane should also be inspected, because it creates a seal which prevents condensation from running down into the joinery. The sill should be examined to insure that it slopes downward away from the building and allows water to drain off. In addition, it may be advisable to cut a dripline along the underside of the sill. This almost invisible treatment will insure proper water runoff, particularly if the bottom of the sill is flat. Any conditions, including poor original design, which permit water to come in contact with the wood or to puddle on the sill must be corrected as they contribute to deterioration of the window.

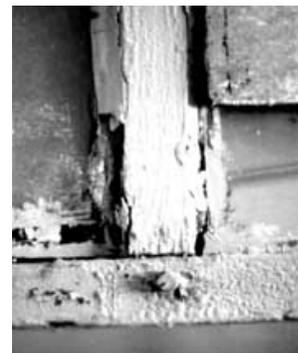
After removing paint from the seam between the interior stop and the jamb, the stop can be pried out and gradually worked loose using a pair of putty knives as shown. Photo: NPS files.

Paint removal should begin on the interior frames, being careful to remove the paint from the interior stop and the parting bead, particularly along the seam where these stops meet the jamb. This can be accomplished by running a utility knife along the length of the seam, breaking the paint bond. It will then be much easier to remove the stop, the parting bead and the sash. The interior stop may be initially loosened from the sash side to avoid visible scarring of the wood and then gradually pried loose using a pair of putty knives, working up and down the stop in small increments. With the stop removed, the lower or interior sash may be withdrawn. The sash cords should be detached from the sides of the sash and their ends may be pinned with a nail or tied in a knot to prevent them from falling into the weight pocket.

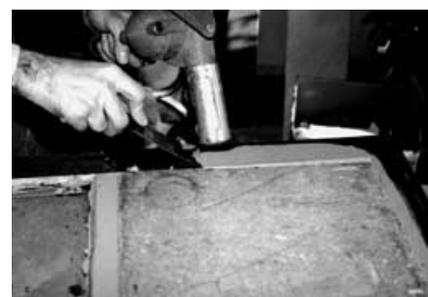
Sash can be removed and repaired in a convenient work area. Paint is being removed from this sash with a hot air gun. Photo: NPS files.

The sash can be stripped of paint using appropriate techniques, but if any heat treatment is used, the glass should be removed or protected from the sudden temperature change which can cause breakage. An overlay of aluminum foil on gypsum board or asbestos can protect the glass from such rapid temperature change. It is important to protect the glass because it may be historic and often adds character to the window. Deteriorated putty should be removed manually, taking care not to damage the wood along the rabbet. If the glass is to be removed, the glazing points which hold the glass in place can be extracted and the panes numbered and removed for cleaning and reuse in the same openings. With the glass panes out, the remaining putty can be removed and the sash can be sanded, patched, and primed with a preservative primer. Hardened putty in the rabbets may be softened by heating with a soldering iron at the point of removal. Putty remaining on the glass may be softened by soaking the panes in linseed oil, and then removed with less risk of breaking the glass. Before reinstalling the glass, a bead of glazing compound or linseed oil putty should be laid around the rabbet to cushion and seal the glass. Glazing compound should only be used on wood which has been brushed with linseed oil and primed with an oil based primer or paint. The pane is then pressed into place and the glazing points are pushed into the wood around the perimeter of the pane.

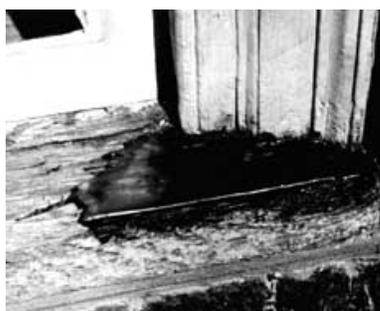
This illustrates a two-part epoxy patching

compound used to fill the surface of a weathered sill and rebuild the missing edge. When the epoxy cures, it can be sanded smooth and painted to achieve a durable and waterproof repair. Photo: NPS files.

Wood may also be strengthened and stabilized by consolidation, using semirigid epoxies which saturate the porous decayed wood and then harden. The surface of the consolidated wood can then be filled with a semirigid epoxy patching compound, sanded and painted. Epoxy patching compounds can be used to build up missing sections or decayed ends of members. Profiles can be duplicated using hand molds, which are created by pressing a ball of patching compound over a sound section of the profile which has been rubbed with butcher's wax. This can be a very efficient technique where there are many typical repairs to
